# Priestthorpe Accessibility Action Plan March 2023

## 4.1 - ACTION TABLE

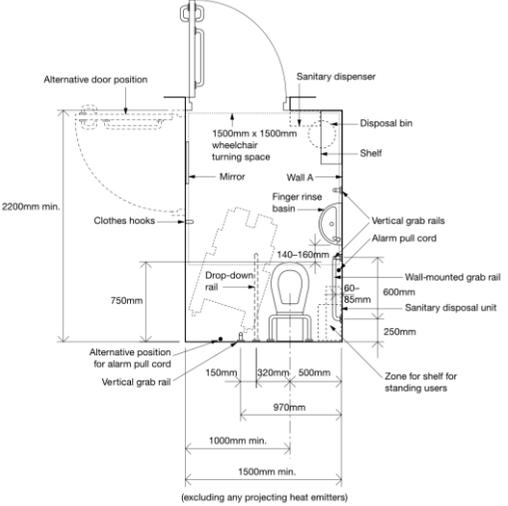
13.1	<p>An accessible WC was provided to the main building, leading directly onto the hall.</p> <p>Entrance width of approximately 900mm, compartment width 2280mm, narrowed to 1720mm due to cupboards. The length of this compartment was 2850mm.</p> <p>The compartment in nursery measured to be approximately 1970mm by 2190mm but was narrowed due to furniture, 1680mm.</p>	<p>Implement a management procedure to ensure that any furnishing provided to the accessible WCs, do not decrease the available size of the compartment to beneath ADM requirements, as shown in Diagram 18:</p>

N	Process in place any accessible toilets will ensure they meet diagram 18 suggestions.

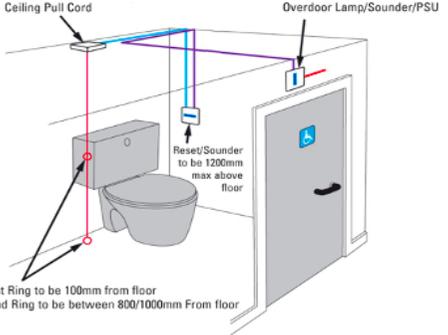
<p>13.11</p>	<p>The reset and exit button were directly next to each other in the facility in the hall, which could cause confusion. These were positioned at approximately 1160mm from ground floor level. The cord alarm in this facility did not feature bangles at two heights.</p> <p>The cord alarm in the nursery facility was looped onto the grab rail. The reset was positioned behind items and would not be easily accessed.</p>

<p>Implement a management procedure to ensure that cord alarms are always kept loose and not tied up.</p> <p>According to BS8300 - An emergency assistance pull cord should be sited so that it can be operated from the WC and from an adjacent floor area. The emergency assistance pull cord, coloured red, should be provided with two red bangles of 50 mm diameter, one set at a height between 800 mm and 1000 mm and the other set at 100 mm above floor level.</p> <p>Both facilities should include an alarm reset button, that is well contrasted from its surroundings, in its correct position on the adjacent wall to the WC at a height of 800mm -1000mm, free from obstruction.</p>	<p>N/M</p>

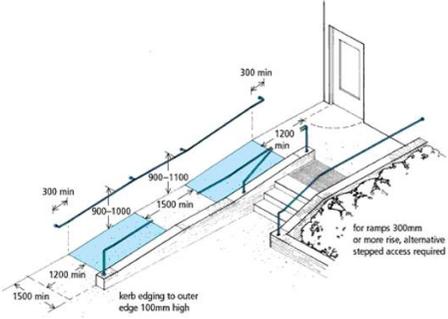
<p>3.2</p>	<p>Handrails were not provided to the ramp leading towards the site management and storage area, or the ramp leading into nursery.</p> <p>The ramp leading into the area near to the main hall had a handrail to one side only.</p>	<p>BS8300 compliant handrails should be installed to both sides of the external ramps.</p> <p>Any handrail provided should have the required 300mm horizontal landing extensions with the entire handrail located at a height of 900mm from the slope and landing surface. The handrails should also be coated with nylon or a suitable alternative to ensure that they are not cold to touch.</p>

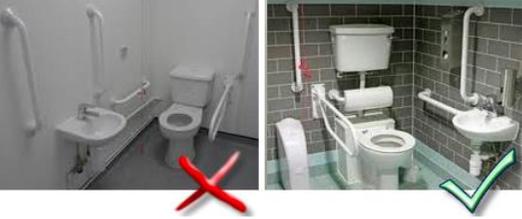
<p>13.6</p>	<p>Suitable lever style taps were provided to both facilities.</p> <p>One hand wash basin in the nursery featured turn style taps which may not be suitable for someone with limited dexterity in their wrists.</p>	<p>The turn style taps should be replaced with lever style, this will aid people with limited dexterity in their wrists.</p> <p>According to BS8300 - Taps should either be mixer taps with an up and down action to control water flow or individual hot and cold lever operated taps with not more than a quarter turn from off to full flow.</p>	<p>M</p>	
<p>13.7</p>	<p>The grab rails provided to the facility in the hall were not well contrasted against their surroundings.</p> <p>Grab rails in the facility near to nursery were well contrasted.</p>

<p>The grab rail set in the hall should be replaced with a new BS8300 compliant set that offers colour contrast.</p> <p>A difference in LRV (Light Reflectance Value) between rail and background of 30 points is considered reasonable. In accessible WCs a blue rail set on white walls is a common accessible combination.</p>	<p>M</p>

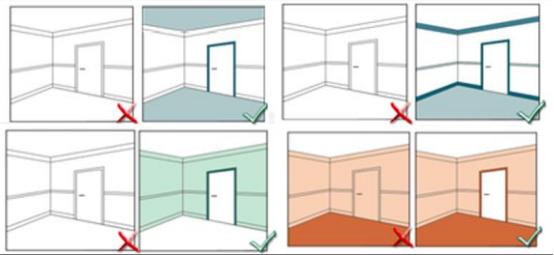
8.1	<p>Most doors across the school were clearly distinguishable from the surroundings.</p> <p>The door leading to the office (room 29), near to the WC facilities by the hall, and the internal face of the door by the upstairs offices, were not distinguishable from their surroundings.</p>	<p>Ideally all doors should have contrast against the surroundings upon which they are seen. The doorway should be easily identifiable when the door is in the closed position, and when the door is in the open position.</p> <p>This could be achieved by painting the door frames a contrasting colour. Adding colour contrast will aid people with impaired vision.</p>	M

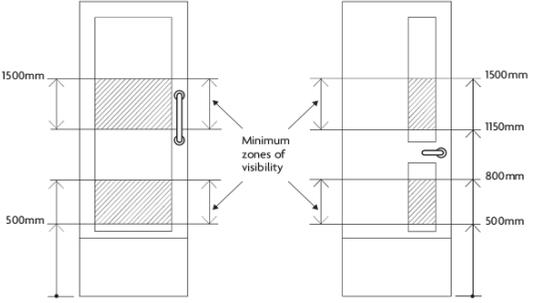
<p>8.3</p>	<p>Most doors featured suitable vision panels.</p> <p>Doors on the first-floor featured vision panels to the top areas of the door only.</p> <p>The doors in nursery featured vision panels that were covered, which may be for safeguarding purposes.</p>

<p>Install new BS8300 compliant doors with vision panels to the first floor.</p> <p>Vision panels need to be included in frequently used doors where privacy (toilets etc.) is not required with a minimum visibility zone between 500mm and 1500mm from floor level and located at the side of the leading edge.</p> <p>Glass should comply with BS6206.</p> <p>It is recommended that site management implement a procedure to ensure that the temporary notices are not on the vision panels. This will prevent a potential collision hazard. If privacy is required, blinds or a suitable alternative could be installed.</p>	<p>M</p>	
<p>8.4</p>	<p>Classroom doors appeared to have suitable opening widths.</p> <p>Doors leading from the hall featured a door and a half system.</p> <p>The double doors into the library area had an available width of approximately 670mm, which may not be suitable for a wheelchair user to pass through when only one leaf is open.</p>	<p>It would be beneficial for wheelchair users to convert these doors to a door and a half system. This would allow wheelchair users a greater clearance width when using the master leaf.</p> <p>Refer to BS8300 -An effective clear width of less than 800 mm may result in people with poor manoeuvring ability or with large wheelchairs not being able to pass through without damage to themselves or the door. Use of the preferred effective clear width more easily accommodates people with assistance dogs and where there is heavy pedestrian traffic.</p>	<p>M</p>

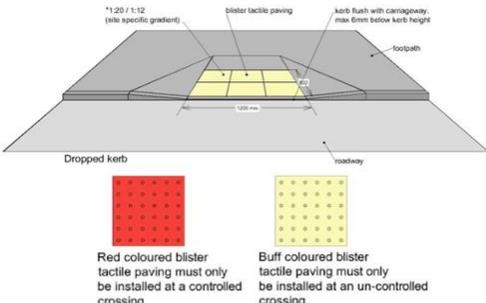
<p>1.2</p>	<p>The crossings on approach to the school featured dropped kerbs; however, tactile paving was not always provided, which could assist people who are partially sighted.</p>	<p>Site management should undertake liaison with the appropriate Council Department to provide tactile paving in the area to aid people with impaired vision.</p>

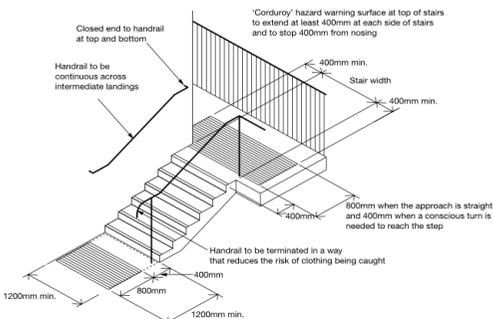
<p>1.10</p>	<p>The rear play area was on a sloping site. The play areas were positioned at the top end of the slopes, towards the rear of the playground areas.</p> <p>A raised garden area was identified that required stepped access.</p>	<p>The playground should include several accessible ground levels with visual, audible and tactile sensory play opportunities. Dynamic pieces should be within easy reach from seated and standing positions. Quiet areas of retreat and gentle sensory experiences should also be provided.</p>	<p>M</p>	
<p>4.1</p>	<p>Tactile warnings were not provided to the external steps surrounding the school.</p>

<p>Implement a rolling programme to install tactile paving to the top of the external steps throughout the site.</p> <p>BS8300 - To give advance warning of a step, tactile paving with a corduroy hazard warning surface should be provided at the top and bottom of each flight, excluding intermediate landings with continuous handrails. Where the approach to the stair is wider than the flight, the tactile surface should extend beyond the line of each edge of the flight.</p>	<p>M</p>

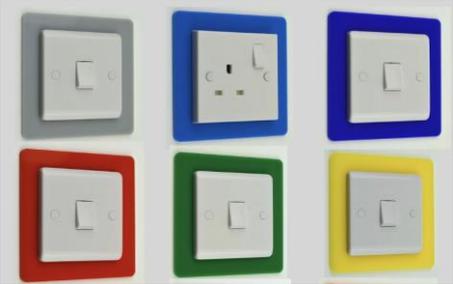
16.2	<p>Light switch plates provided across the school were not well contrasted. Some of which were positioned high from ground floor level and may not be accessible for all users.</p>

<p>At the next refurbishment for the sites, it would be beneficial to change the existing light switch plates with alternatives that have a grey/silver plate.</p> <p>Alternatively, light switch plates with a contrasting surround could be used.</p> <p>This will ensure that they are easily located by people with impaired vision.</p>	M
